National Energy Board

Reasons for Decision

Interhome Energy Inc.

Review of Recommendation 5.9: Integrity of
Existing Pipelines, of the National Energy
Board Report MH-2-85 dated June 1986.

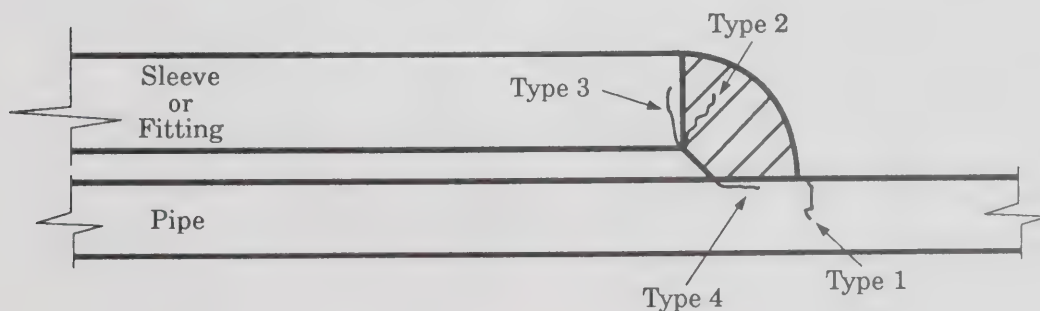
Four general types of sleeve or fitting to pipe fillet weld cracks have been recognized and are illustrated in Figure 1 below. The type 1 crack is referred to as a "toe" crack. A toe crack such as this was determined by the Inquiry Panel to have propagated circumferentially through the pipe wall causing the line break near Camrose. The type 2, 3 and 4 cracks are referred to as "root" cracks. The potential occurrence of fillet weld root cracks came to light during the conduct of the weld inspections for this review. Where the nature of the root cracks detected was identified, they were indicated to be predominantly of type 2 with isolated occurrences of type 3. Although type 4 cracks are identified as a potential type of fillet weld crack, no report of such cracks has in fact resulted from the inspection programs.

Potential Fillet Weld Crack Types

Type 1- Toe crack

Types 2, 3, and 4 - Root cracks
